OBSERVATIONS ON AN AILERON-FLUTTER INSTABILITY ENCOUNTERED  
ON A 45° SWEEP-BACK WING IN TRANSONIC AND SUPERSONIC FLIGHT

Marvin Pitkin, William N. Gardner  
and Howard J. Curfman, Jr.

Langley Memorial Aeronautical Laboratory  
Langley Field, Va.

April 11, 1947

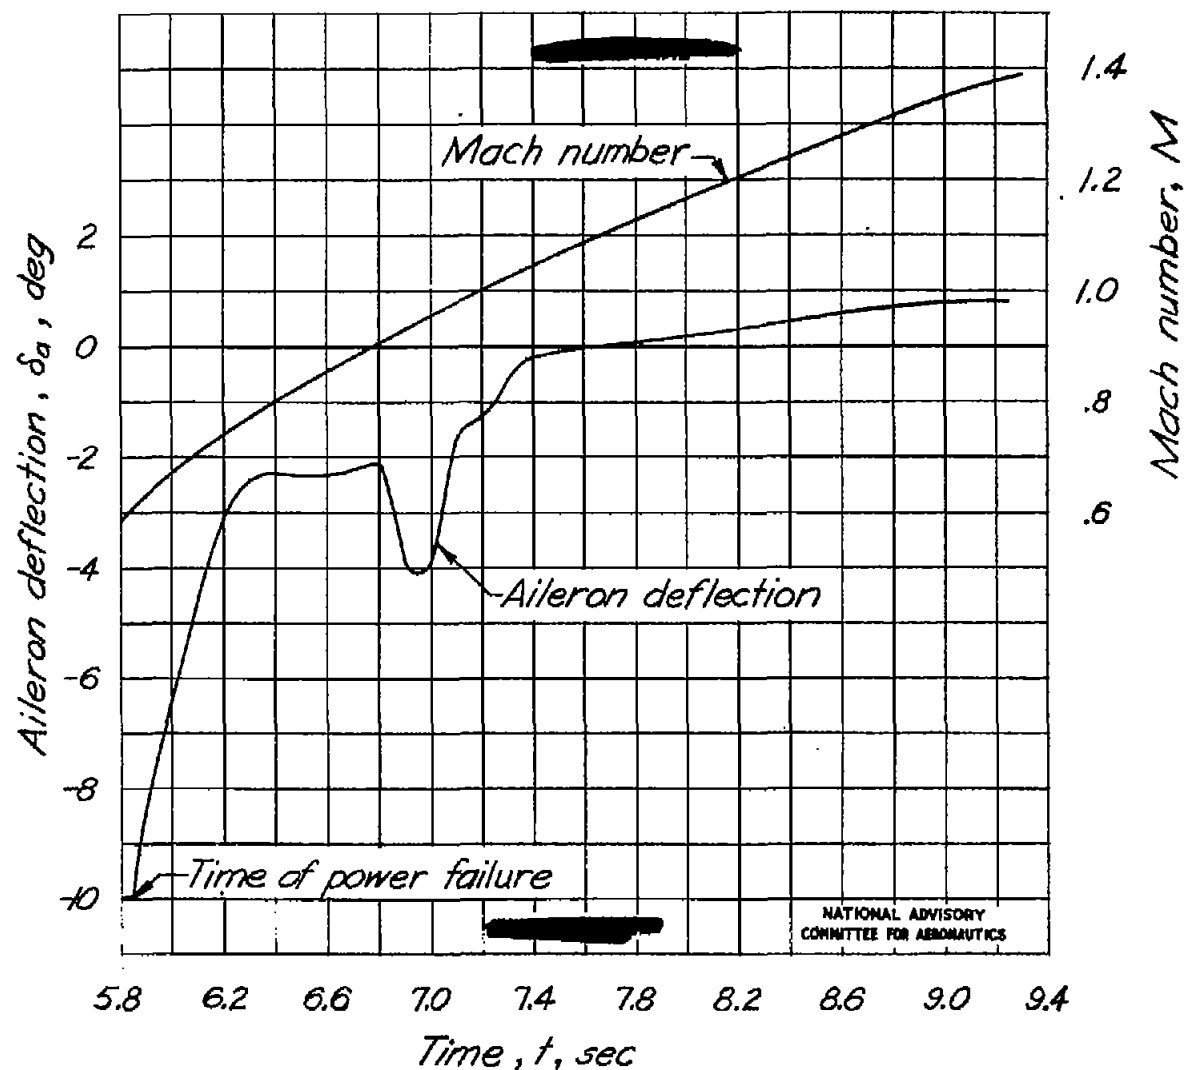
Telemeter records showed that normal operation of the ailerons and automatic pilot was experienced prior to the power failure. The model stabilized in roll during this period, and a rolling oscillation of  $\pm 3.5^\circ$  amplitude was obtained up to the time the sustaining rocket ignited (5.8 seconds). After this time, the control was free floating. Figure 8(a) shows the aileron behavior and Mach number variation for the time the sustaining rocket was firing. These data are cross-plotted in figure 8(b) to show the variation of control deflection with Mach number.

(a) Aileron deflection and Mach number against time.  
Figure 8.- Aileron characteristics in accelerated flight.
